<b>GENERAL INFORMATION</b>	Social housing for elderly people
Building owner	Bregovo Municipality
Address	Village Kudelin
Number of dwellings	48 before refurbishment and after refurbishment
Number of floors	3
Average size of the dwellings	12 m <sup>2</sup> before refurbishment and after refurbishment
Total heated floor area	1,120 m <sup>2</sup> before refurbishment and after refurbishment
Year of construction	1973
Year of refurbishment	2007
Has the refurbishment been carried out while the dwelling was occupied?	Yes
Has an independent quality assurance been carried out?	An energy audit has been carried out. The quality of reconstruction has been approved by licensed experts.
Total building costs	101,853 €
Building costs concerning energy recovery	101,853 €
<b>INITIAL SITUATION/LOCAL CONDITION</b>	<ul style="list-style-type: none"> <li>• Poor condition of insulation of external walls</li> <li>• Poor condition of insulation of roof</li> <li>• Lower indoor air temperature that is not in compliance with national ordinances</li> </ul>

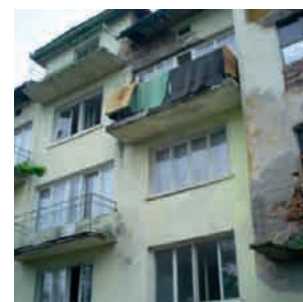
before refurbishment

<b>SUBSIDIES</b>	75 % of the refurbishment investments is obtained through credit and 25 % is financed by the municipality
<b>STATEMENT</b>	The general condition of building was estimated to be poor and inadequate for living of the tenants due to the poor condition of insulation of external walls and roof. It was concluded that 63 % energy saving could be achieved after applying a package of 4 energy saving measures.
<b>CONTACT</b>	Black Sea Regional Energy Centre – BSREC 8, Triaditza Str. 8 1040 Sofia Phone: +35 9298068-54 E-mail: office@bsrec.bg
