GENERAL INFORMATION	
Building owner	Sozialhilfverband Weiz (Social welfare assistance federation)
Address	Weiz, Styria, Austria
Number of dwellings	77 before and after refurbishment
Number of floors	4
Average size of the dwellings	56 m <sup>2</sup> before refurbishment 65 m <sup>2</sup> after refurbishment
Total heated floor area	4,321 m <sup>2</sup> 4,978 m <sup>2</sup>
Year of construction	1973
Year of refurbishment	2005–2006
Has the refurbishment been carried out while the dwelling was occupied?	Yes
Has an independent quality assurance been carried out?	No
Total building costs	2,150,000 €
Building costs concerning energy recovery	1,190,000 €

#### INITIAL SITUATION/LOCAL CONDITION

#### TYPE OF REFURBISHMENT (MEASURES WHICH HAVE BEEN CARRIED OUT)

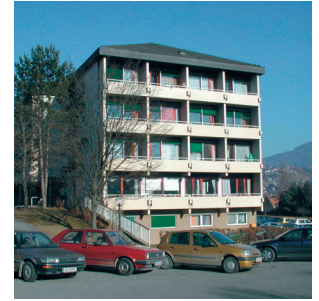
before refurbishment

- outdoor walls and parapets made out of vertically perforated bricks U-Value of 0.96 W/(m<sup>2</sup>K).
- Top ceiling towards attic insulated with 7 cm heat insulation.
- Windows: single wooden windows with 2 layers isolation glass.
- Heating: district heating
- Domestic hot water: partly solar thermal system with energy storage

- Insulation top ceiling (22 cm)
- Insulation outer wall towards out door air (16 cm)
- Insulation outer wall towards non heated room (12 cm)
- Insulation outer wall towards ground (12 cm)
- Insulation basement towards non heated room (12 cm)
- Insulation basement and floor towards out door air (8–16 cm)
- Insulation basement floor (8 cm)
- Insulation heat bridges (8–16 cm)
- New coupled windows + forward spaced façade with 3 layered glass
- Ventilation with 70% heat recovery
