## Block of flats No.10

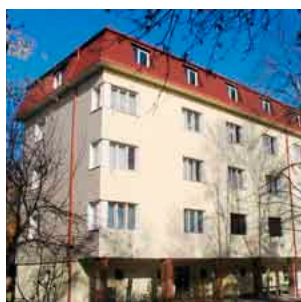
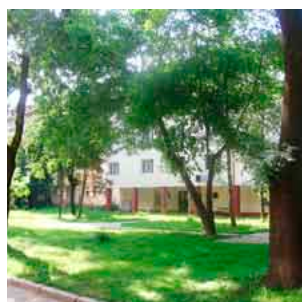
after refurbishment

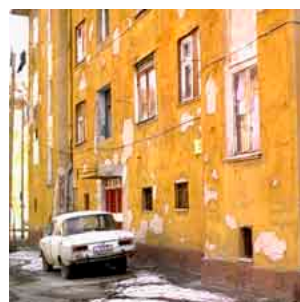
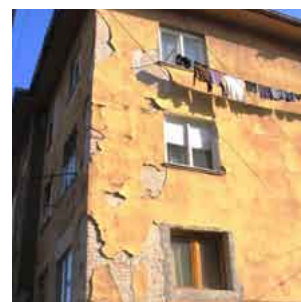
before refurbishment
