GENERAL INFORMATION	Dormitory, building 1 of „School dormitories“
Building owner	Municipality
Address	Town of Kardjali
Number of dwellings	42 before refurbishment 42 after refurbishment
Number of floors	3
Average size of the dwellings	
Total heated floor area	999.01 before refurbishment 999.01 after refurbishment
Year of construction	1960
Year of refurbishment	2007
Has the refurbishment been carried out while the dwelling was occupied?	Yes
Has an independent quality assurance been carried out?	An energy audit has been carried out. The quality of reconstruction has been approved by licensed experts.
Total building costs	30,555 €
Building costs concerning energy recovery	30,555 €
INITIAL SITUATION/LOCAL CONDITION	<ul style="list-style-type: none"> • Poor condition of insulation of external walls • Poor condition of insulation of roof • High infiltration and bad condition of windows
TYPE OF REFURBISHMENT (MEASURES WHICH HAVE BEEN CARRIED OUT)	<ul style="list-style-type: none"> • Replacement of windows • Thermal insulation of walls • Thermal insulation of roof

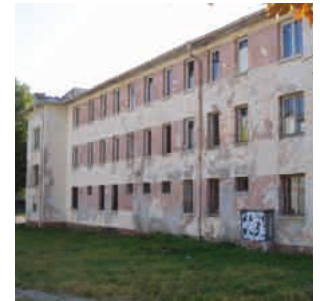
before refurbishment

PROMOTION	
SUBSIDIES	100 % financed by the Municipality
STATEMENT	The general condition of the building was estimated to be poor and inadequate for living of the tenants due to high air infiltration through the windows as well as poor roof and external wall insulation. After an energy audit of experts, the result was that total energy savings of 65 % could be achieved after applying three different energy saving measures (new windows, better external wall and roof insulation).
CONTACT	Black Sea Regional Energy Centre – BSREC 8, Triaditza Str. 8 1040 Sofia Phone: +35 9298068-54 E-mail: office@bsrec.bg
