GENERAL INFORMATION	
Building owner	Gesellschaft für Bauen und Wohnen Hannover mbG (GBH), association for construction and living in Hannover
Address	Beuthener Straße 25–31, Hannover-Mittelfeld
Number of dwellings	24 social housing units (before and after refurbishment)
Number of floors	3
Average size of the dwellings	dwellings with 3 rooms, floor area of about 66 m ² (before and after refurbishment)
Total heated floor area	1,592 m ² (before and after refurbishment)
Year of construction	1957
Year of refurbishment	2004/2005
Has the refurbishment been carried out while the dwelling was occupied?	The complete refurbishment measures have been carried out while the flats were (partially) occupied.
Has an independent quality assurance been carried out?	
Total building costs	approx. 1,055,000 € total
Building costs concerning energy recovery

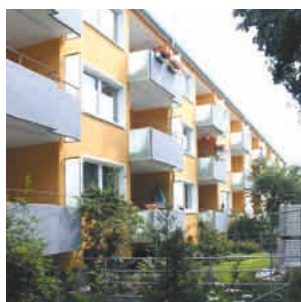
after refurbishment

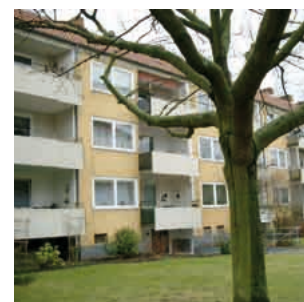
before refurbishment
