GENERAL INFORMATION	The building is located in the town Pruszcz Gdański near Gdańsk city.
Building owner	ownership community
Address	Pruszcz Gdańsk, Raciborskiego Str. 3
Number of dwellings	18 before refurbishment 18 after refurbishment
Number of floors	3
Average size of the dwellings	42.7 m ² before refurbishment 42.7 m ² after refurbishment
Total heated dwelling floor area	768.7 m ² before refurbishment 768.7 m ² after refurbishment
Year of construction	1971
Year of refurbishment	2003
Has the refurbishment been carried out while the dwelling was occupied?	Yes
Has an independent quality assurance been carried out?	No
Current total building costs	24,500 €/a (water, waste water, waste, electricity, heat, administration, refurbishment fund)
Current building costs concerning energy recovery	11,500 €/a

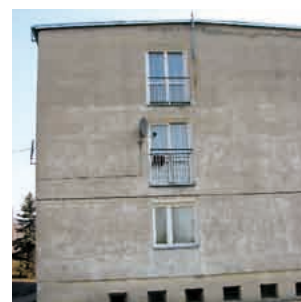
before refurbishment

INITIAL SITUATION/LOCAL CONDITION	<ul style="list-style-type: none"> the outer gable walls are 38 cm thick, made of prefabricated hollow concrete units with insulation (U-value = 0.89 W/(m²K)) the outer longitudinal walls are 24 cm thick, made of gas concrete bricks (U-value = 1.15 W/(m²K)) the floors are made of prefabricated hollow concrete slabs (no girders), insulated with 3 cm of mineral wool (U-value = 0.87 W/(m²K)) the flat roof is insulated with 8 cm of mineral wool and additional 10 cm of foamed polystyrene (U-value = 0.24 W/(m²K)) windows have double wooden frames (U-value = 2.6 W/(m²K)), most of them have been replaced by tenants with windows which have a single vinyl frame and double-pane glazing (U-value about 1.5 W/(m²K))
TYPE OF REFURBISHMENT (MEASURES WHICH HAVE BEEN CARRIED OUT)	<ul style="list-style-type: none"> insulation of building envelope improvement of heating system
